PROGRAM TITAN IIIM
STANDARD SPACE LAUNCH VEHICLE
DEVELOPMENT REPORT
FOR
STAGE I ENGINE DEMONSTRATION TESTING

Report 9180-941-DR-9

31 March 1969

Aerojet-General Corporation
Liquid Rocket Operations
Sacramento, California
95809

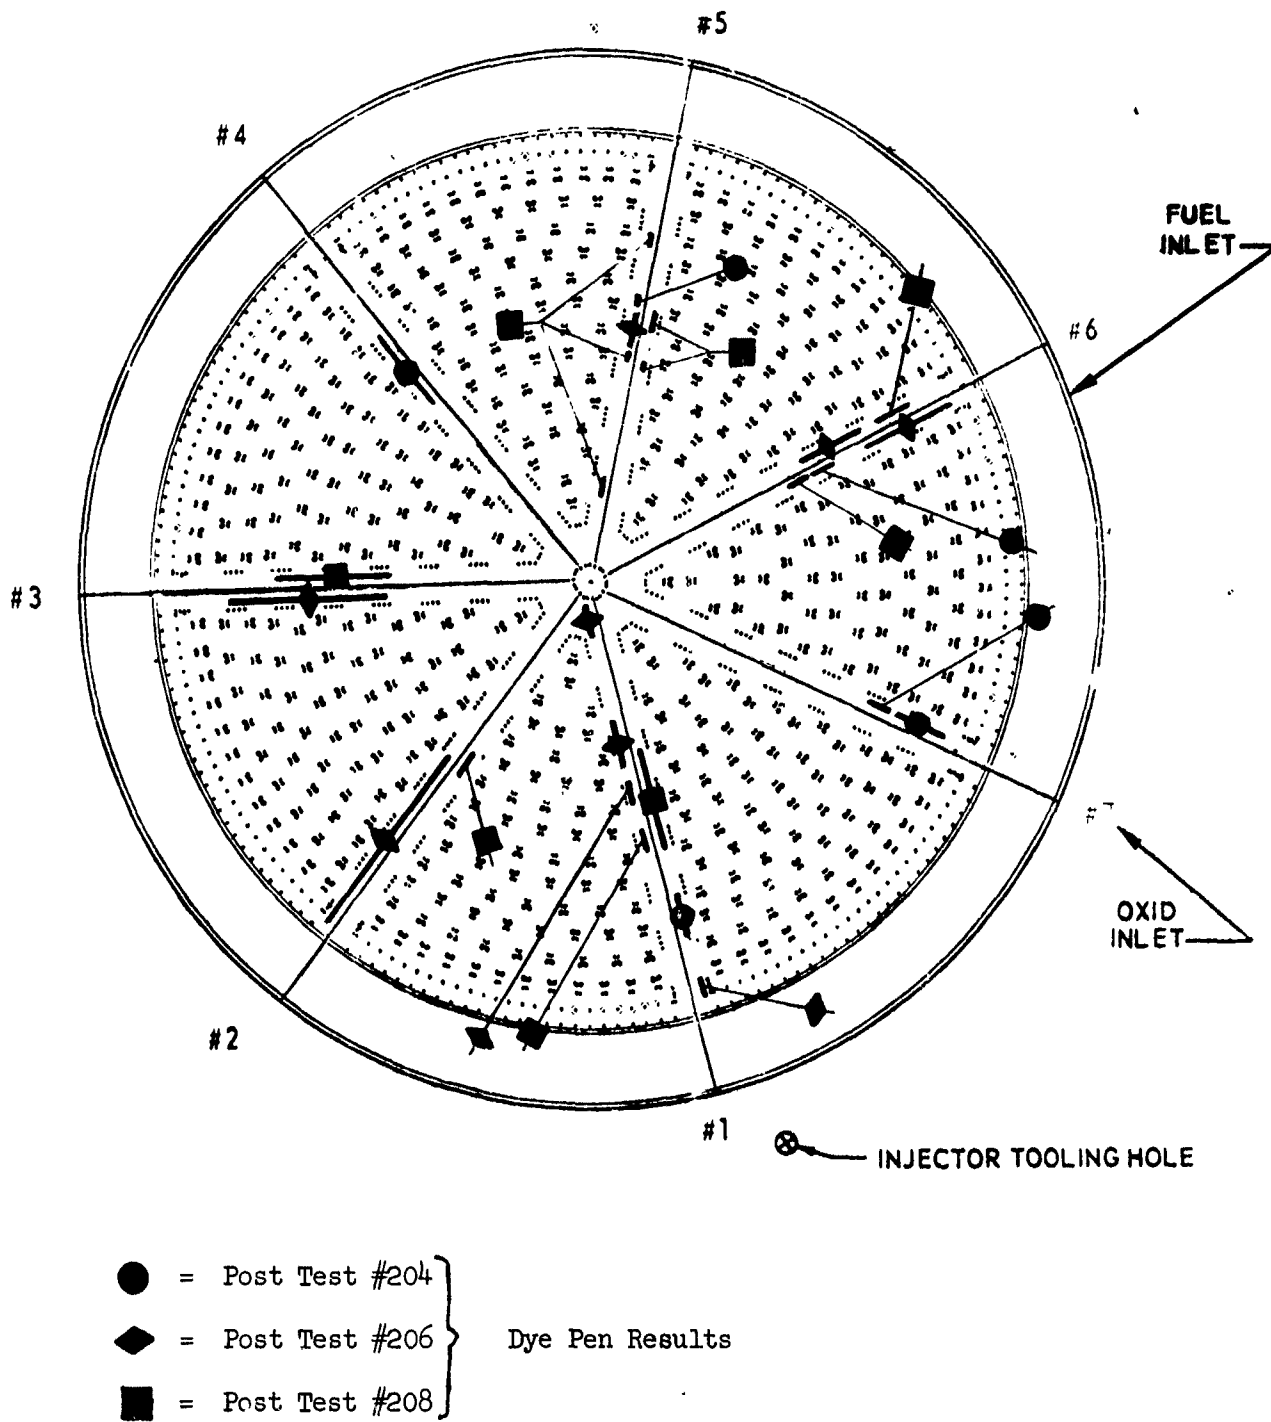
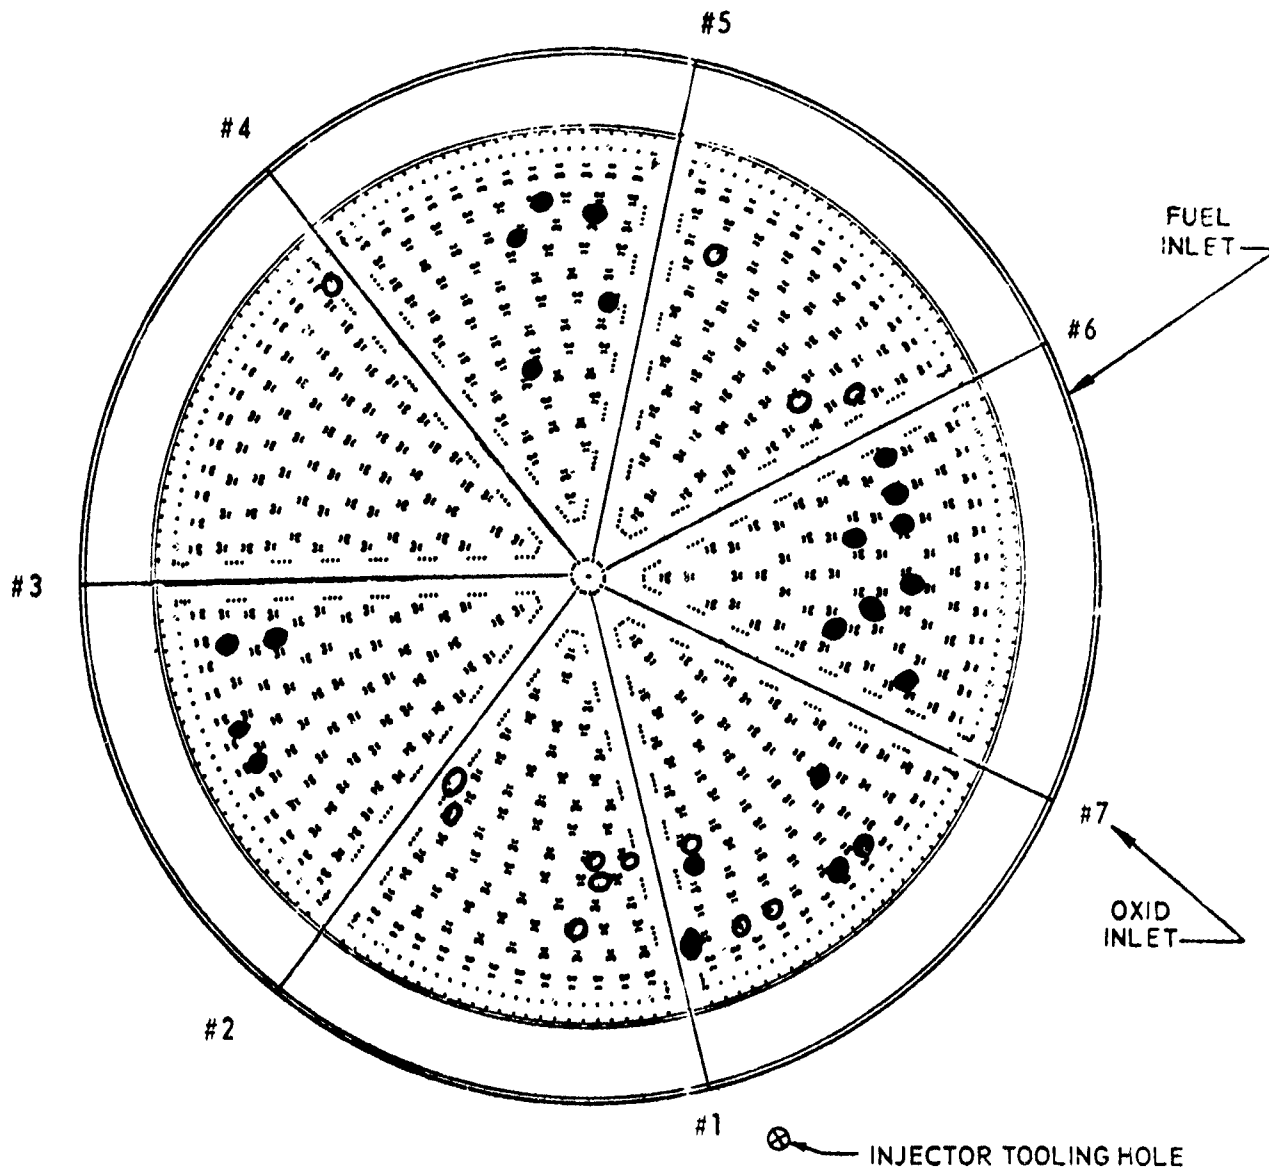
Figure 69--Location of Base Weld Cracks, Injector S/N 696, (1 of 2)

The cause of the weld cracking was determined to be an improper weld preparation and application. The base of the baffle legs was supposed to be beveled at a 45° angle to a depth of 0.060 inches. The fillet weld was supposed to fill this bevel, thereby forming a total fillet thickness greater than the baffle wall thickness. However, the bevel was less than 0.030 inches deep, and the thickness of the resulting fillet weld was slightly less than the thickness of the baffle wall. Also, the lack of weld penetration formed a discontinuity in the transmission of stresses from the baffle to the injector face, thereby increasing the bending stresses in the weld by 50% over what they would be with proper weld penetration. The resulting stress concentration and weak joint led to a premature fatigue failure at the weld joint.

- = Post Test #206 (Dye Pen Results, 13 Indications Total)
- = Post Test #208 (Dye Pen Results, 25 New Indications, 38 Total)

d. The frequency and number of injector baffle weld cracks were the result of insufficient weld penetration. Improved procedures which reduced the discrepancy incidences rate were implemented successfully.

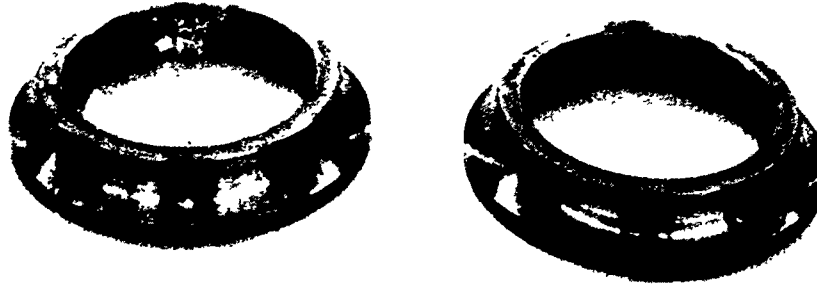
Figure 75 -- Bearing B-10, S/N 1462 -- Inner Races

Two corroded bearing assemblies were found in one TPA gearbox during the post program final disassembly. These bearings were on the same fuel pump that seal leakage occurred.
